Manhole Inspection Summary

Manhole # S25K__002MH

Location Address: **203 S. Woodyear St**

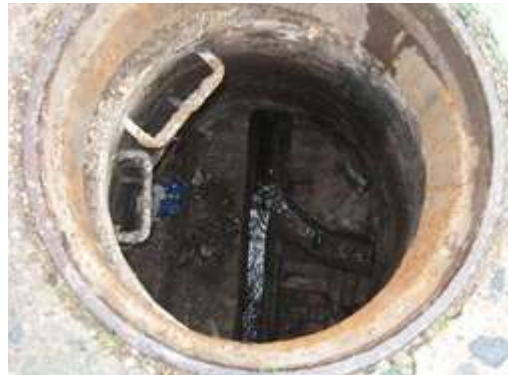
Top View

Frame Offset: **3** (in.)

Steps Count: **3** Missing: **0** ☒ **Corroded**

frame offset, corroded steps, infiltration from chimney-frame-lid connect

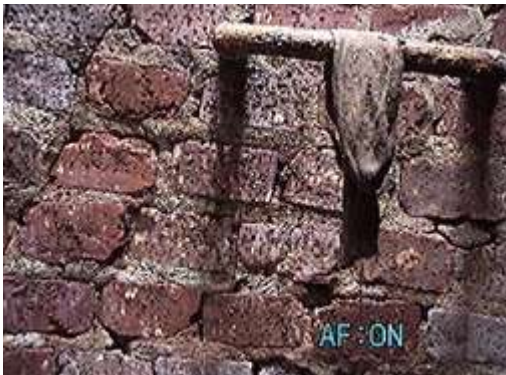
Defect 3

☒ **Leaks**

lid-frame infiltration

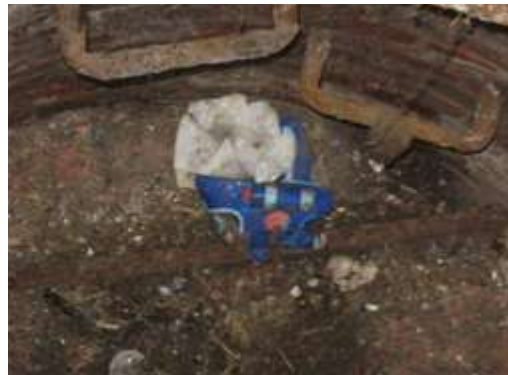
Defect 2

Surcharge ☒ **Evidence Of Surcharge** Depth: **3** (ft.) ☐ Active Surcharge Present

Evidence of surcharge

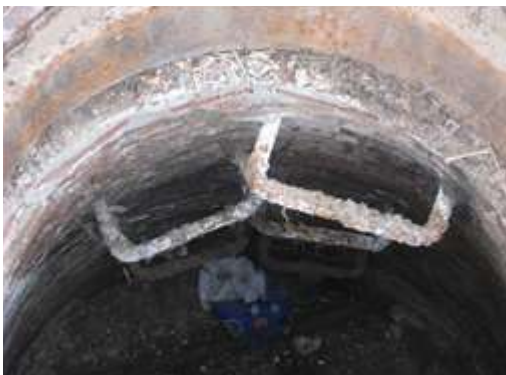
Defect 1

Condition: ☐ Sound ☐ Cracked ☐ Root Intrusion ☐ Deteriorated ☐ Leaks ☒ **Debris**

Debris on bench

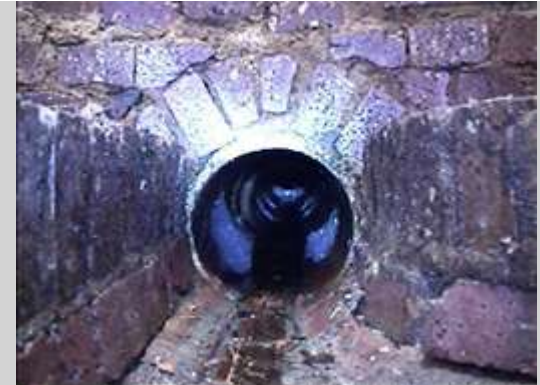
12 O'Clock Outflow

8 in. Circular Gravity Sewer
Pipe Out @ 12 O'Clock

Pipe Height: **7.2** (in.) Rod and Bar (Angled)
Pipe Material: **Clay** ☐ Pipe Lined
Invert Depth: **8.37** (ft.) Flow Characteristics: **Slow**
Deposits: ☒ None ☐ Mud ☐ Sludge ☐ Debris ☐ Grease
Silt Depth: **0** (in.) Deposits Extent:
Infiltration: **None** Pipe Seal Cond: **Sound**

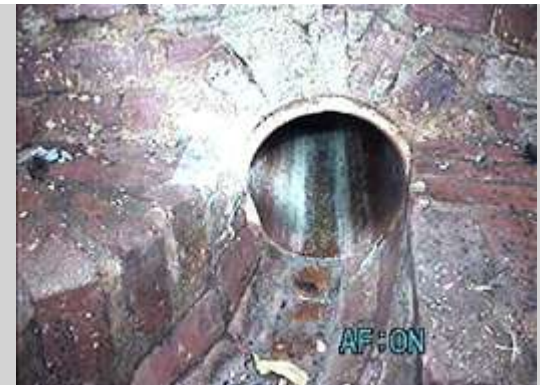
3 O'Clock Inflow

8 in. Circular Gravity Sewer
Pipe In @ 3 O'Clock

Pipe Height: **8.4** (in.) Rod and Bar (Angled)
Pipe Material: **Clay** ☐ Pipe Lined
Invert Depth: **8.21** (ft.) Flow Characteristics: **Slow**
Deposits: ☒ None ☐ Mud ☐ Sludge ☐ Debris ☐ Grease
Silt Depth: **0** (in.) Deposits Extent:
Infiltration: **None** Pipe Seal Cond: **Sound**

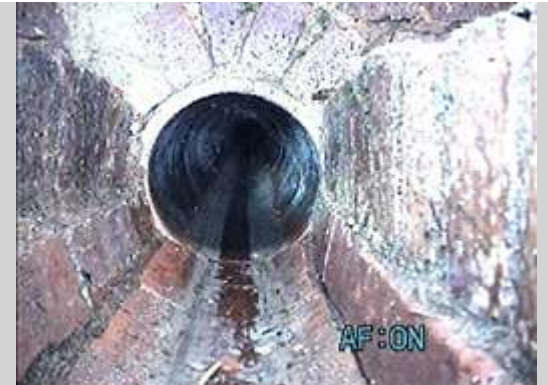
6 O'Clock Inflow

8 in. Circular Gravity Sewer

Pipe In @ 6 O'Clock

Pipe Height: **8.4** (in.) Rod and Bar (Angled)

Invert Depth: **8.38** (ft.) Flow Characteristics: **Slow**

Infiltration: **None** Pipe Seal Cond: **Sound**
